**ROMOBE LAKE DAM**

**NDI No. PA 00051**

**PHASE I INSPECTION REPORT  
NATIONAL DAM INSPECTION PROGRAM**

**April 1981**

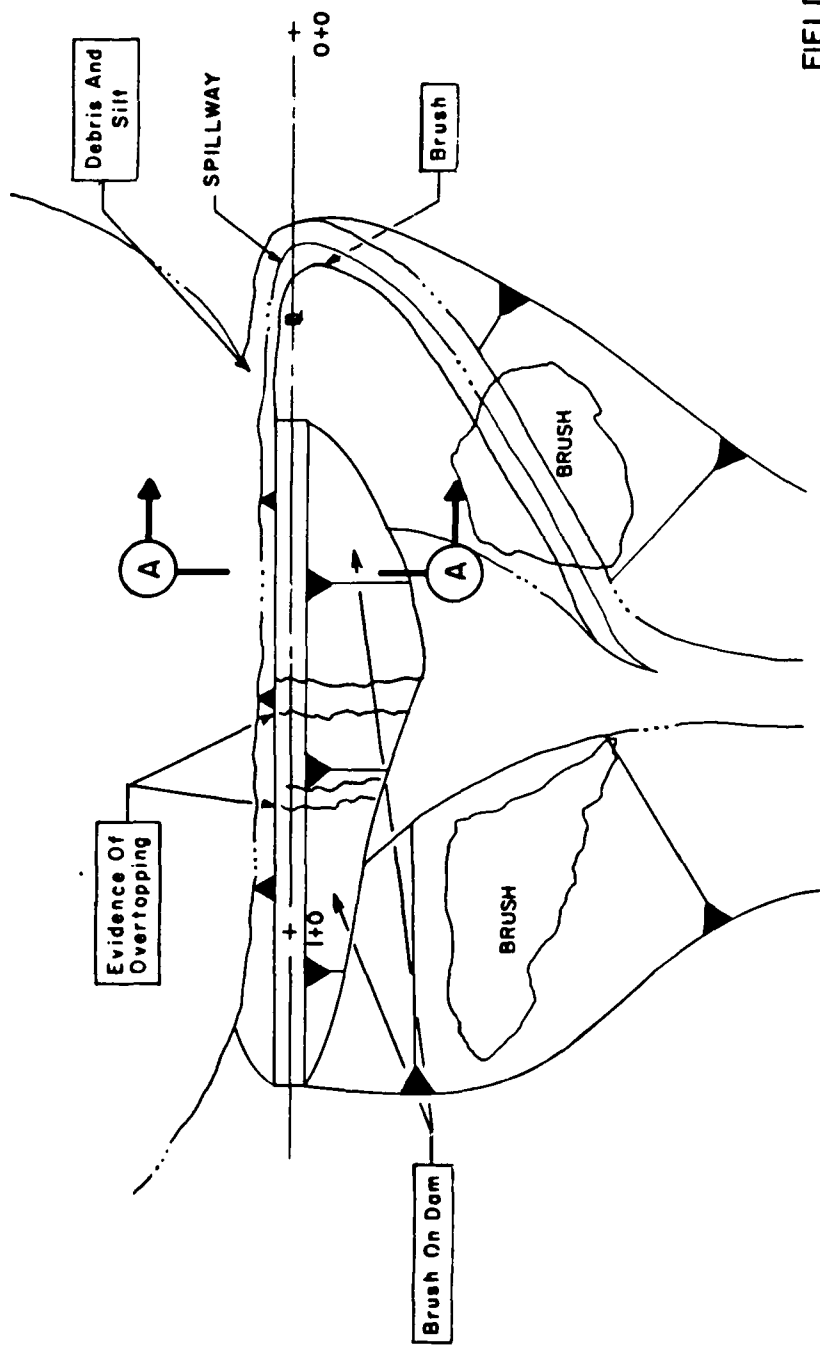
FIELD SKETCH  
 ROMOBE LAKE DAM  
 NDI NO. PA00051  
 Penn DER NO. 58-10  
 SCHEMATIC-NOT TO SCALE

VISUAL EXAMINATION OF	OBSERVATIONS	REMARKS OR RECOMMENDATIONS
SURFACE CRACKS CONCRETE SURFACES	Not applicable	
STRUCTURAL CRACKING	Not applicable	
VERTICAL AND HORIZONTAL ALIGNMENT	The dam shows evidence of having been overtopped previously. This over- topping must have occurred since the last inspection photographs were taken (1965).	The dam should be repaired and an adequate spillway provided.
MONOLITH JOINTS	Not applicable	
CONSTRUCTION JOINTS	Not applicable	
VEGETATION	The dam is overgrown with brush.	Cut the brush.
